Monitoring Data Record

Project Title: R-0210C (Sites 4 and 5) COE Action ID: 1993-0-0570
 Stream Name: Unnamed tributary to the Little Crane Creek DWQ Number: 010404
 City, County and other Location Information: Intersection of Service Rd. and Oak Leaf Rd. off of US 1 (Vass Bypass) in Lee County (Sta. 22+00 to Sta. 24+80)
 Date Construction Completed: March 2004 Monitoring Year: (1) of 5
 Ecoregion: _____ 8 digit HUC unit 03030004
 USGS Quad Name and Coordinates: _____

UT Little Crane Creek

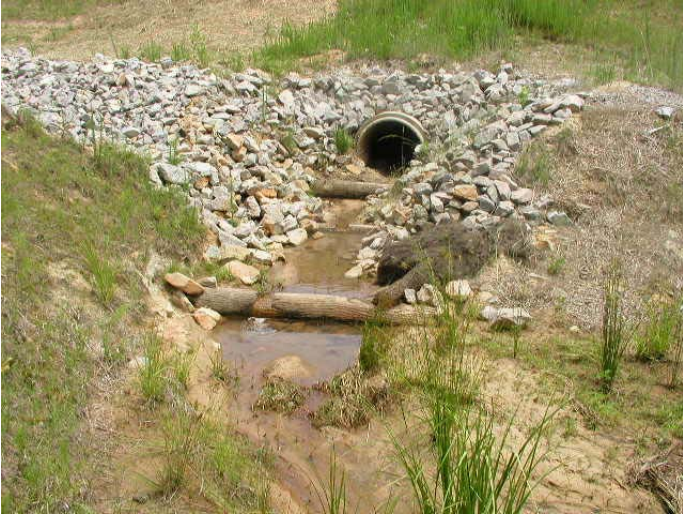
Photo 1

The stream is stabilized for the 1st year of monitoring. The log vane structure noted in photo 1 is set to high which is causing water to go under the log vane. This log vane will be reset to correct the elevation of the structure. The sediment control stone noted throughout the site will be removed before supplemental planting takes place.

Date Inspected	Station Number	Station Number	Station Number	Station Number	Station Number
Structure Type	24 +80 @ log vane				
Is water piping through or around structure?	Water is piping under the log vane				
Head cut or down cut present?					
Bank or scour erosion present?					
Other problems noted?
